# 2018 Recycle Pond A Inspection Report

Entergy Arkansas, LLC White Bluff Plant Recycle Pond A (South) Redfield, Arkansas

> January 2019 Project No. 35187288A

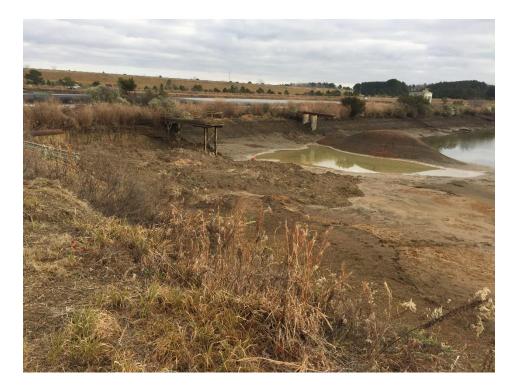
1. Pond A, east side.

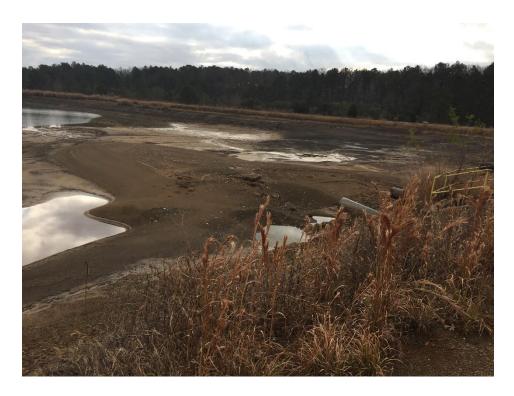
2. Pond A, west side

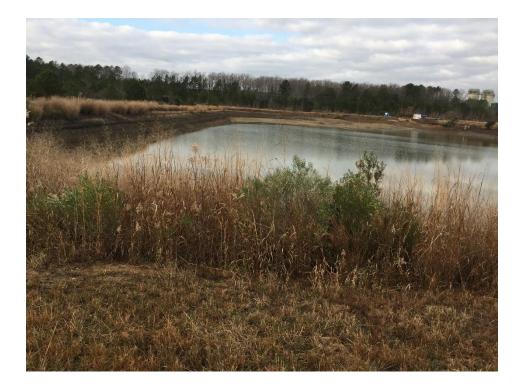
3. Pond A, south side.

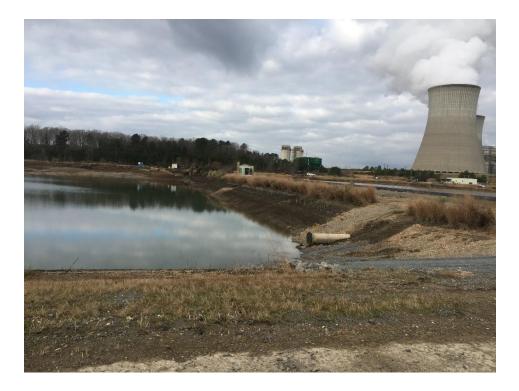
4. Pond A, north side.
