2020 Recycle Pond A Inspection Report

Entergy Arkansas, LLC White Bluff Plant
Recycle Pond A (South)
Redfield, Arkansas

January 2021
Project No. 35207213

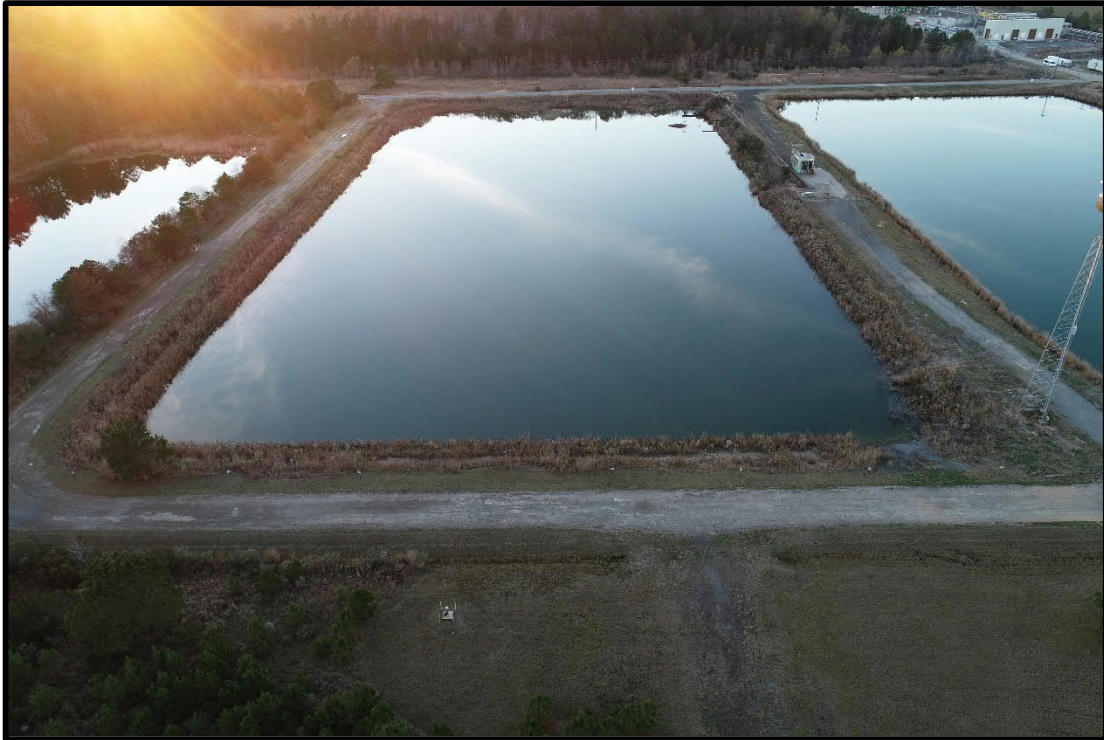
1. Looking west at the east side of Pond A. Stormwater is present/retained in the pond.

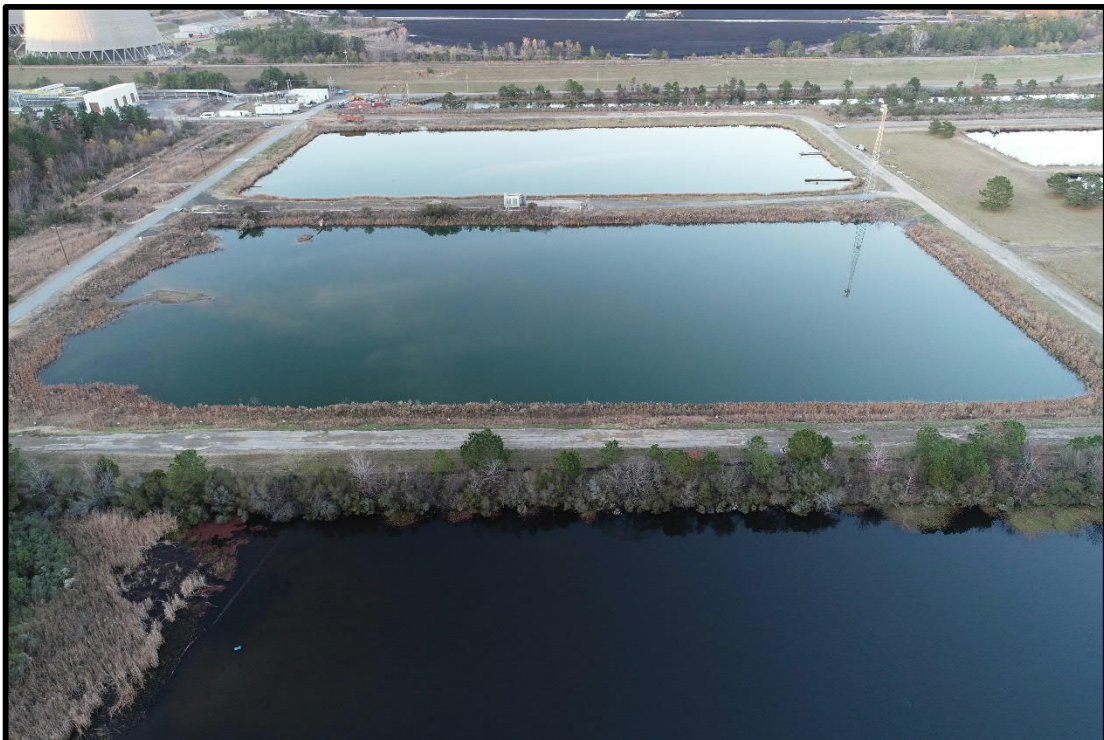
2. Looking north at the south side of Pond A. Stormwater is present/retained in the pond.

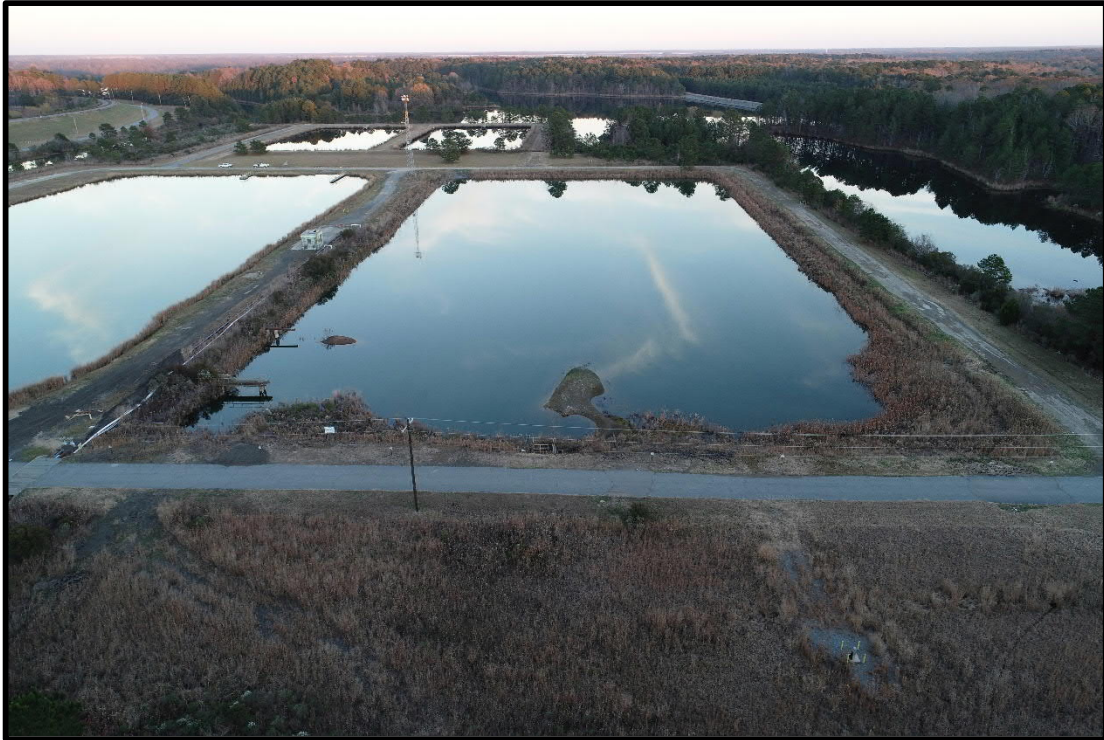
3. Looking east at the west side of Pond A. Stormwater is present/retained in the pond.

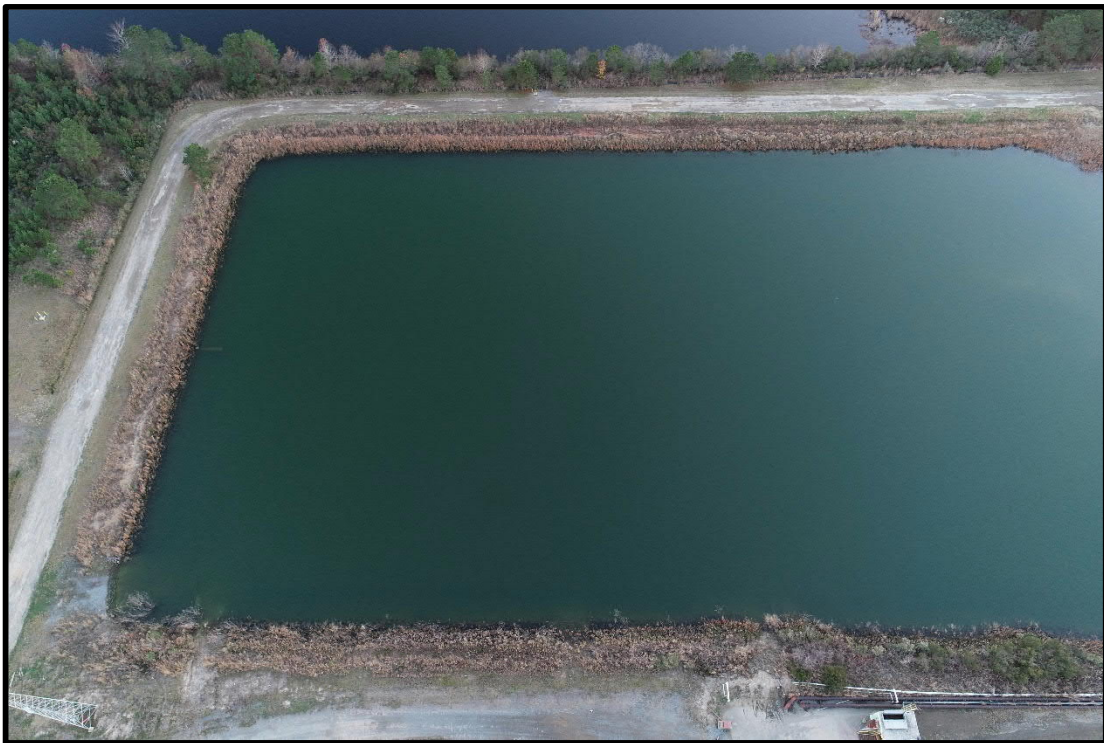
4. Looking down at east side of Pond A. Stormwater is present/retained in the pond.

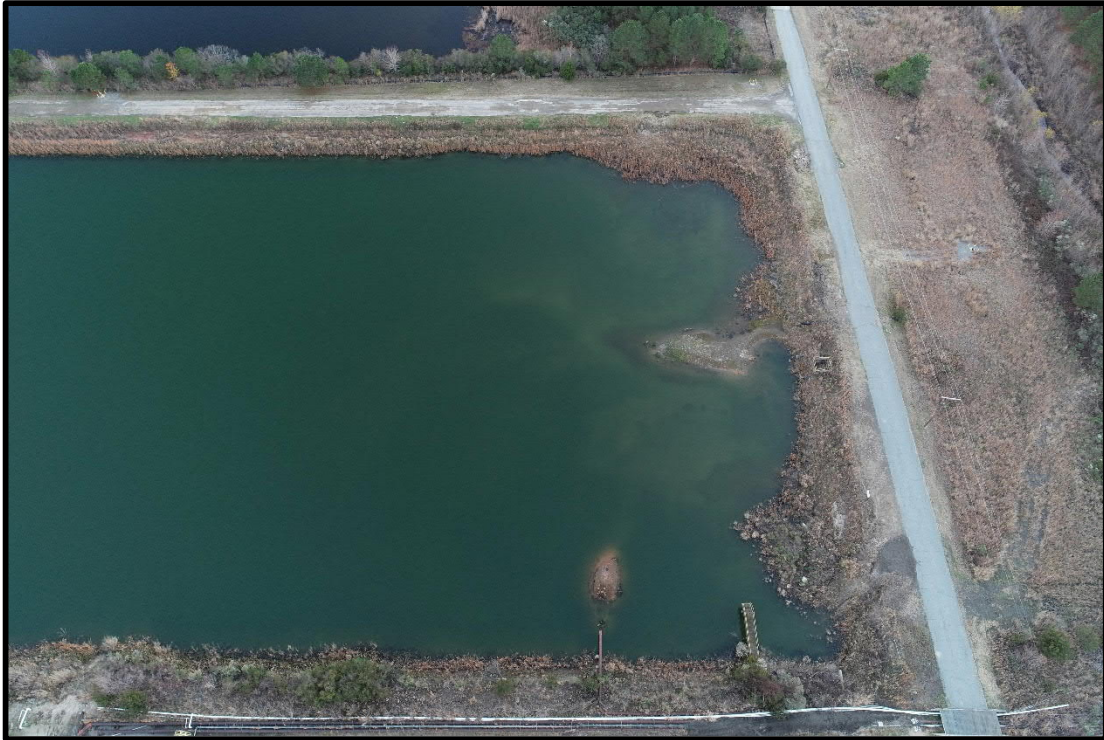
5. Looking down at the west side of Pond A. Stormwater is present/retained in the pond.
