2022 Recycle Pond A Inspection Report

**Entergy Arkansas, LLC White Bluff Plant
Recycle Pond A**

**January 2023
Promus Project No. 220197**

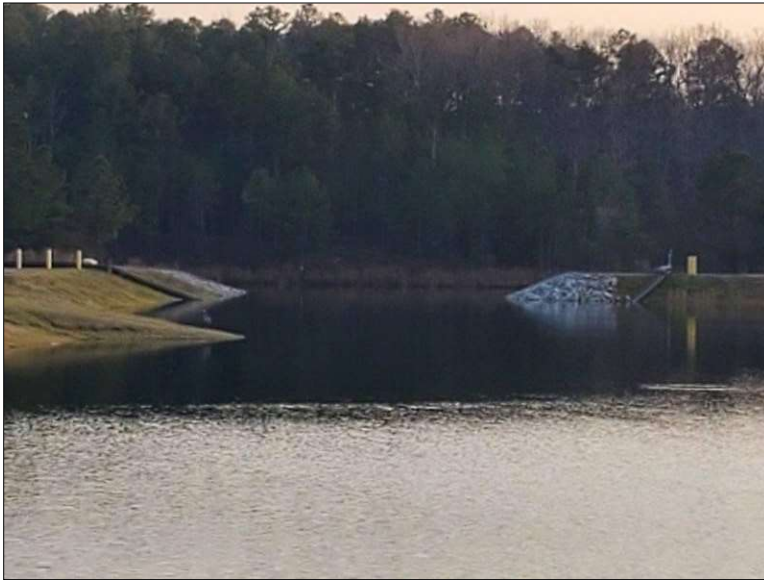
Photo No. 1

Looking at the southeast corner of Recycle Pond A where the south dike was breached during closure construction to the Clear Water Holding Pond.

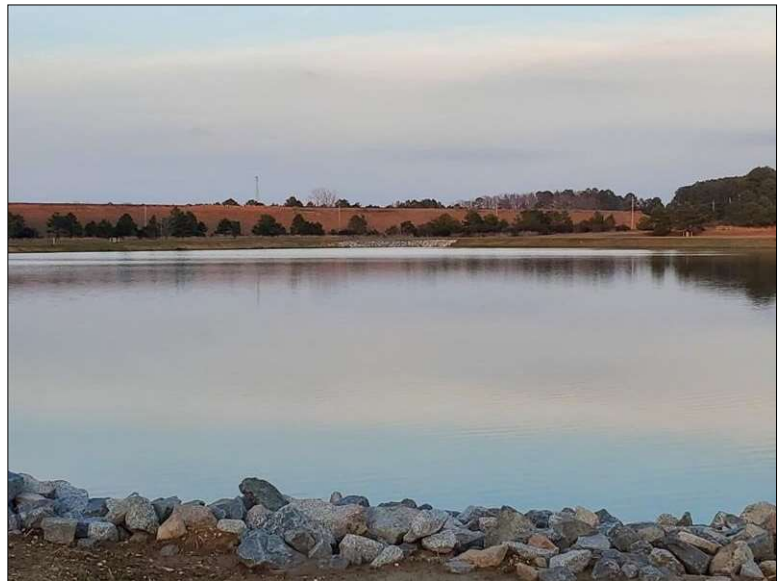
Photo No. 2
Looking across Recycle Pond A from the southwest corner to the northeast corner.

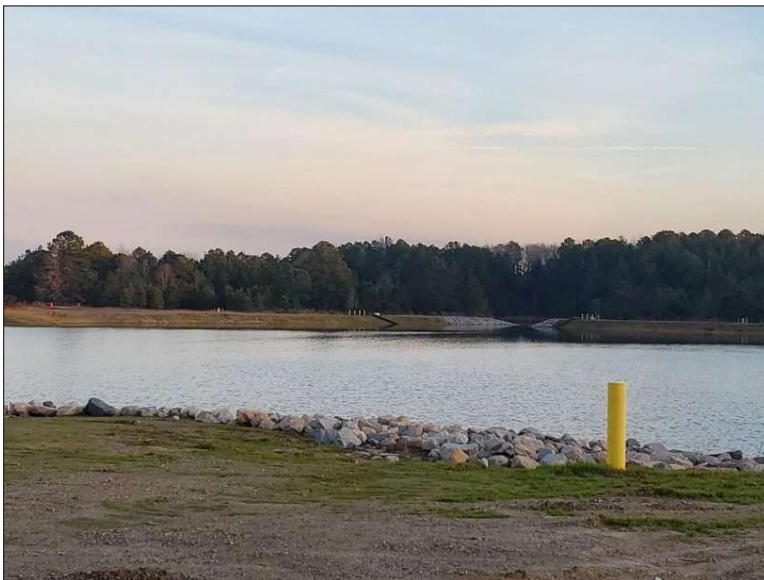
Photo No. 3

Looking across Recycle Pond A from the northwest corner to the southeast corner.
